Manhole Inspection Summary

Manhole # S57G__021MH

Location Address: **310 s haven st**

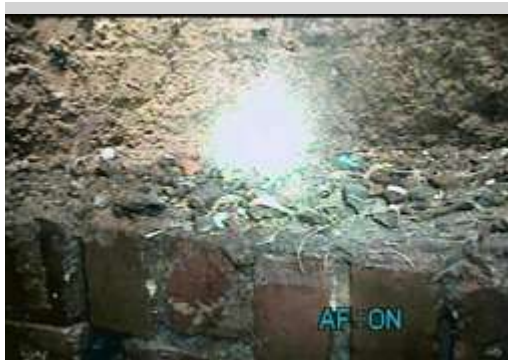
Defect 2

Condition: ☐ Sound ☐ Cracked ☐ Root Intrusion ☐ Deteriorated ☐ Leaks ☒ **Debris**

bench debris

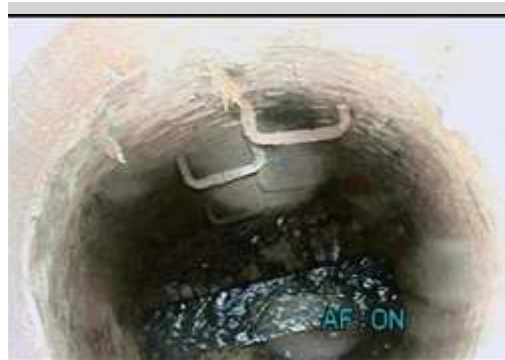
Defect 1

Steps Count: **5** Missing: **1** ☒ **Corroded**

corroded and missing steps

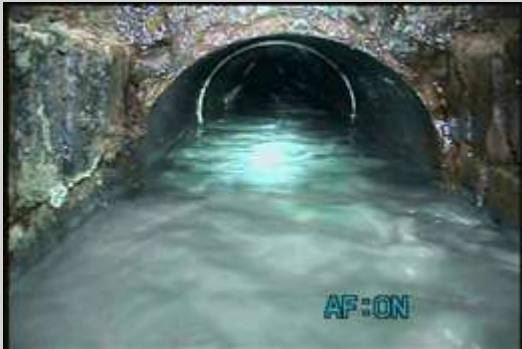
12 O'Clock Outflow

12 in. Circular Gravity Sewer
Pipe Out @ 12 O'Clock

Pipe Material: **Clay** ☐ Pipe Lined

Invert Depth: 8.87 (ft.) Flow Characteristics: **Fast**

Deposits: ☒ None ☐ Mud ☐ Sludge ☐ Debris ☐ Grease

Infiltration: **None** Pipe Seal Cond: **Unknown**

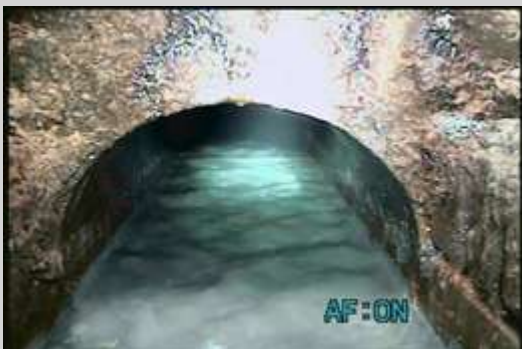
6 O'Clock Inflow

12 in. Circular Gravity Sewer
Pipe In @ 6 O'Clock

Pipe Material: **Clay** ☐ Pipe Lined

Invert Depth: 8.85 (ft.) Flow Characteristics: **Fast**

Deposits: ☒ None ☐ Mud ☐ Sludge ☐ Debris ☐ Grease

Infiltration: **None** Pipe Seal Cond: **Unknown**
